RAILROAD COMMISSION OF TEXAS

SURFACE MINING AND RECLAMATION DIVISION

RE: San Miguel Electric Coop, Inc.
San Miguel Mine, Permit No. 11G
Final Action Notification, NOV 114A

**Statement of Inspector's Observations
Notice of Violation No. 114A
Issued to San Miguel Electrical Cooperative, Inc.
San Miguel Mine, Permit No. 11G**

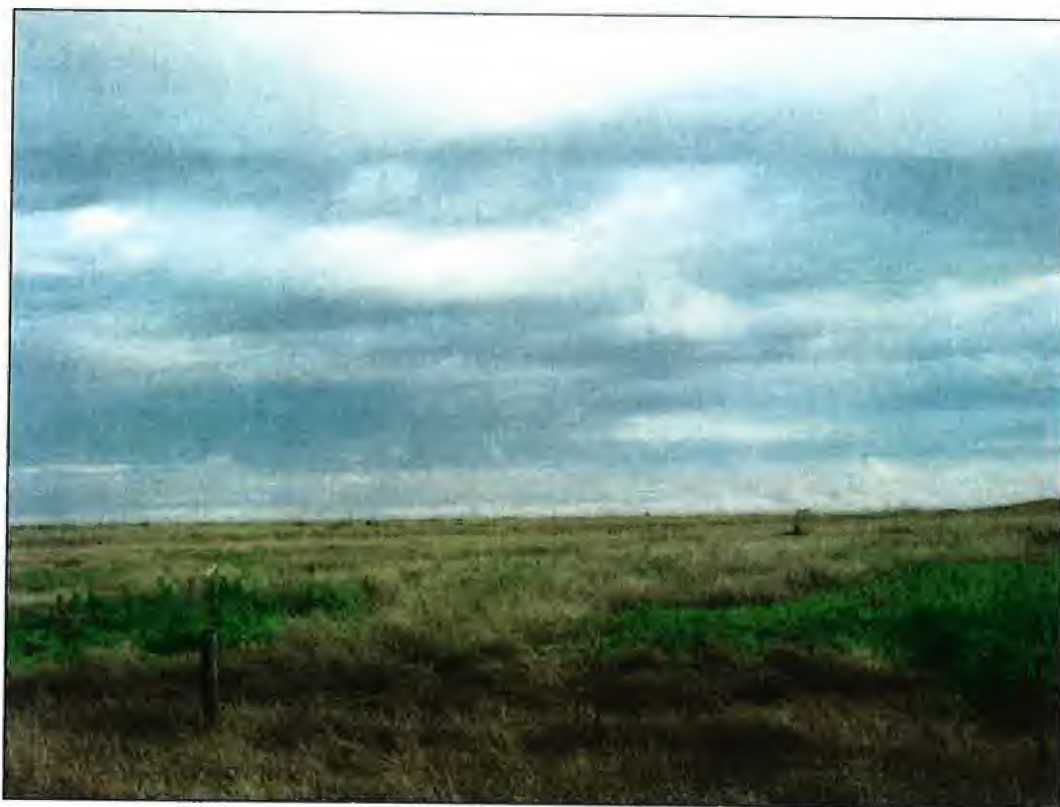
Vegetation has emerged from dormancy and is greening up on all areas of the mine (photo 1 and 2).

Photo 1. Typical vegetation in the A area (view south).

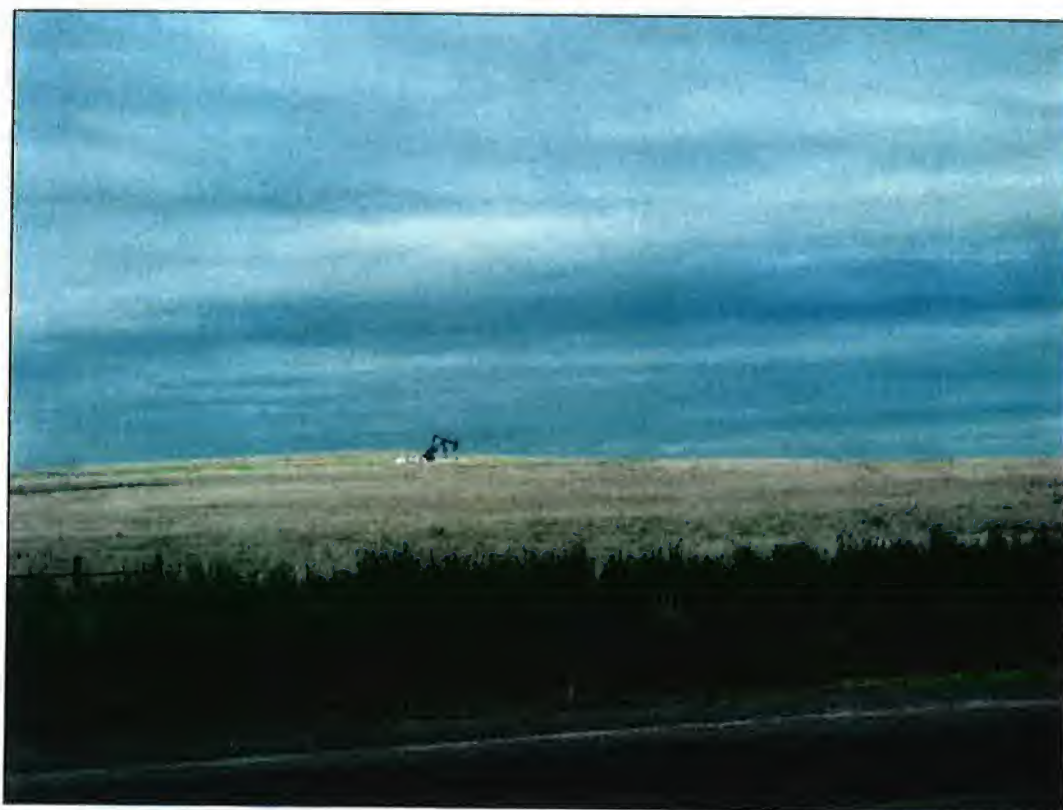
Photo 2. Typical vegetation in the E area (view northeast).
